Dust Reduction (Plaster)

CASE STUDY

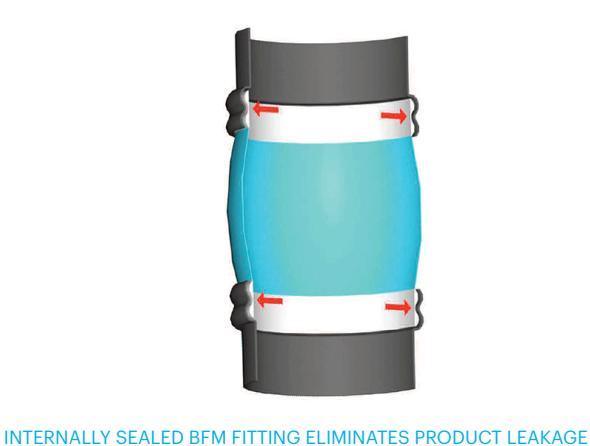
BFM® Seeflex 040AS (anti-static) sleeves have been fitted to both the

inlet and outlet to the vibratory feeder with great results. To date, the

BFM[®] connectors have lasted over 50 times longer than the previous

jubilee-clip fastened sleeve, saving a huge amount of expense in both
